ROTARY DRUMS

REVISION OF COMPONENTS

EVALUATION OF ROTARY KILN STATE BY THE THERMO VISUAL EXAMINATION

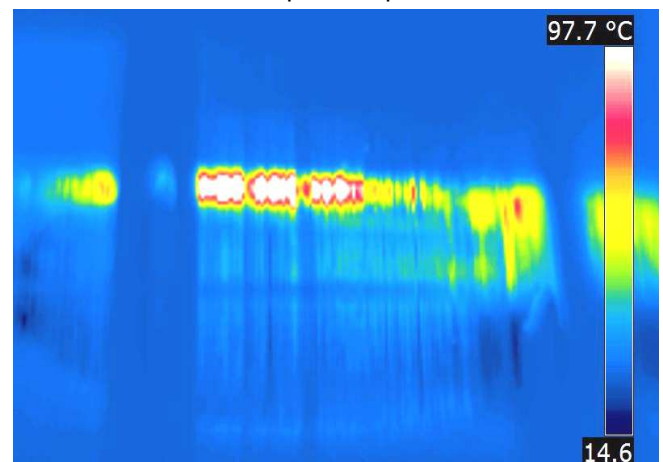
VERIFICATION OF SUPPORT SYSTEM ELEMENTS' STATE

Verification of support system elements' state contains:

- in case of open (half sleeve) bearings – journals state revision, to find any spots of increased temperature – being a result of improper lubrication and/or uneven pressure distribution,
- in case of close (rolling or bushing) bearing – revision of housing state, with the purpose of catching the symptoms of increased temperature inside them,
- in case of support rollers with bearings' cooling system – mostly with forced water circuit – revision of circuit patency by the measurement and evaluation of the inlet and outlet port temperature.

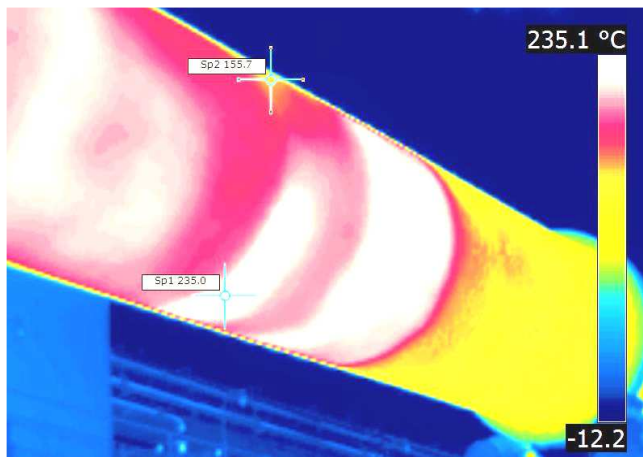
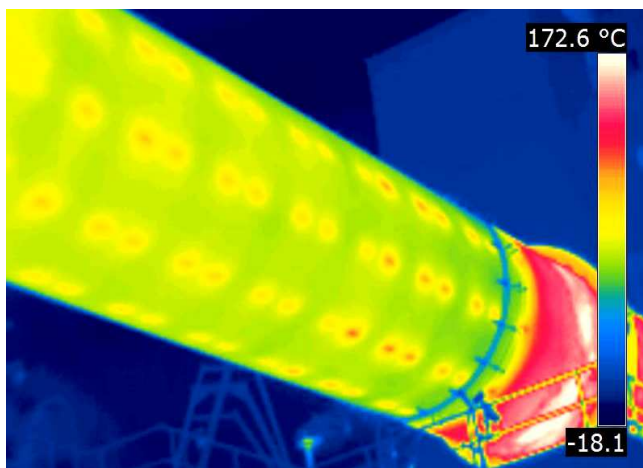
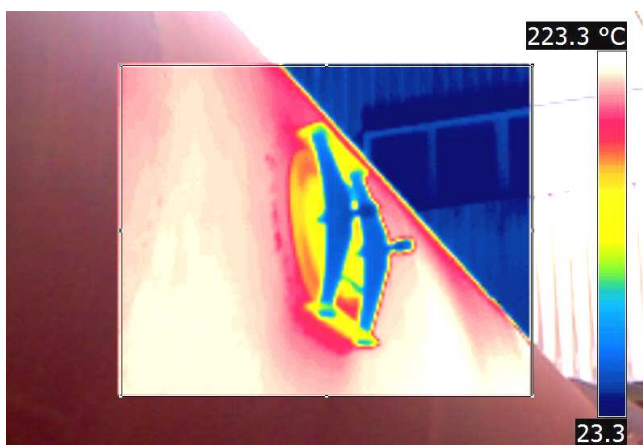
VERIFICATION OF SHELL STATE

Verification of shell state is the most popular area of application of thermo vision in diagnostic of rotary kiln. Most of the kilns are equipped with their own temperature scanners, thanks to which we can obtain the distribution of infrared radiation on the kiln circumference in any section along the kiln axis.

To make diagnostic more detailed or to make it at all (in case of lack of scanner), Eurokiln recommends detailed revision of kiln shell from the close distances, so we would be able to discover:

- damages of thermal insulation (internal or external),
- losses or areas of excessive thickness accretion.

Both cases are specially dangerous if are causing the uneven temperature distribution on the kiln circumference, effecting in bend of shell geometrical axis and its deformations.

Additionally we can examine other details present on the shell or connected with the shell, detecting for example leakages on manholes, openings or even macro cracks of the material.

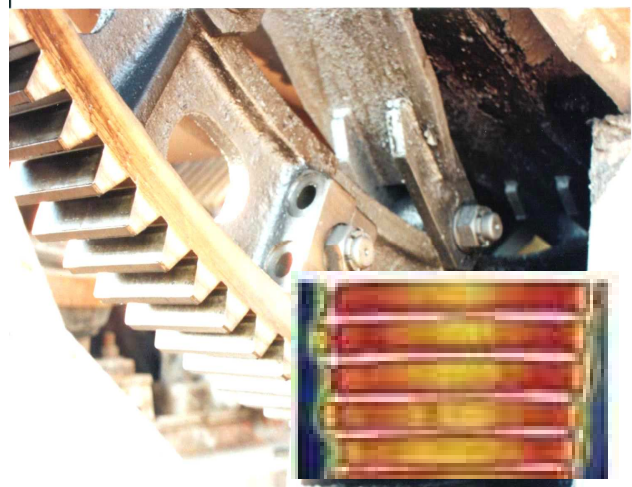
- evaluation of proper meshing of open gear teeth; thermo imaging of pinion teeth and/or gear rim may point to the increased thrust or increased slip; both cases are driving to the excessive wear of teeth because of adequately, excessive contact stresses or excessive wear off of the contact surfaces (notice: measurement quality and analysis effectiveness depends on state of surface (if oiled up), rotation speed and environment conditions during observation; so the measurement of that kind is recommended to be used during assembly of open gear – as verification – after final positioning of pinion and/or gear rim – the best during the start up phase and/or grinding in of co-acting parts – best without lubricating agent; measurements taken on the normal production should be considered as rough ones only,

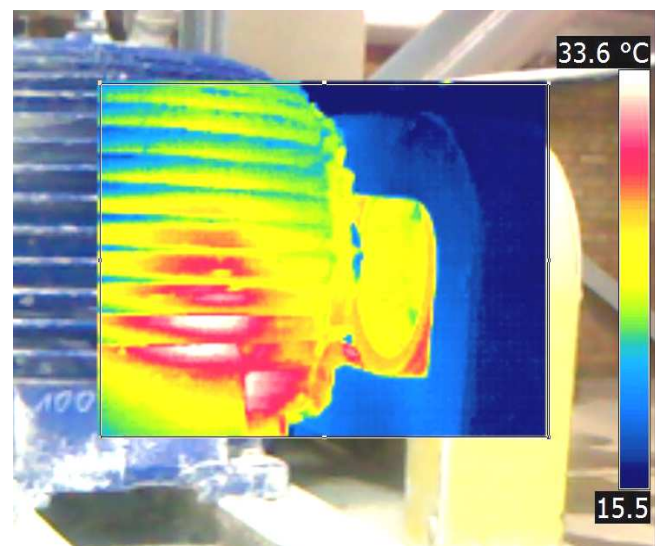
- evaluation of reducer, main motor and couplings state; thermal image analysis in that case is focused on the areas of: bearings, shaft seals and couplings; all areas of significantly increased temperature may point on the abnormalities like for example: bearing's failure and/or improper lubrication, improper functioning of the sealing and/or its improper lubrication, damages of coupling elements and/or improper exploitation conditions (like incorrect shafts alignment).

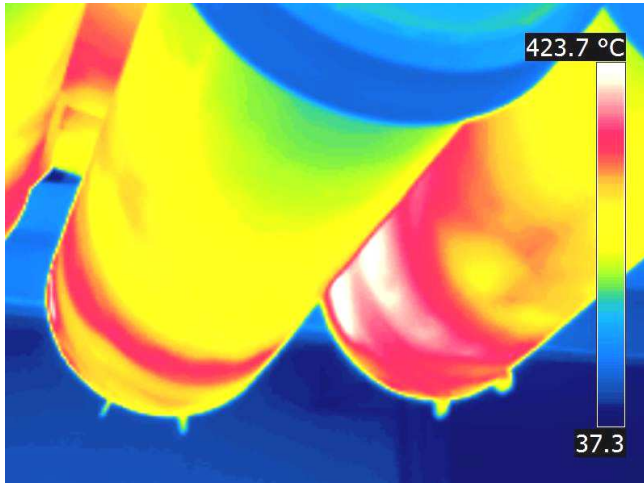
VERIFICATION OF OTHER ELEMENTS AND PERIPHERAL APPLIANCES STATE

During the thermo visual inspection our engineers accomplishes also penetrating revision of other, sometimes optional, elements of the kiln, like for example:

- thrust rollers,
- kiln inlet and outlet sealing,
- planetary coolers.
